A Review of Australian and New Zealand Investigations on Aeronautical Fatigue During the Period April 2009 to March 2011

Air Vehicles Division

Defence Science and Technology Organisation

DSTO-TN-0993

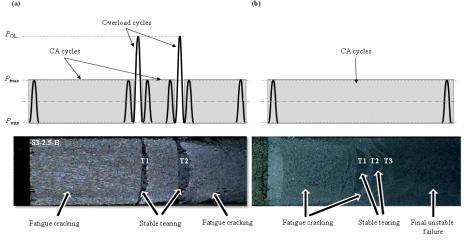
Figure 2: Stable tearing on fracture surface of a 6.5 mm thick 7075 aluminium alloy compact tension specimen. (a) The VA tear bands (marked T1 and T2) were produced during two high loads (overloads) in between background of low fatigue cycles; and (b) The three CA tear bands are marked as T1 to T3. The crack grows from left to right.

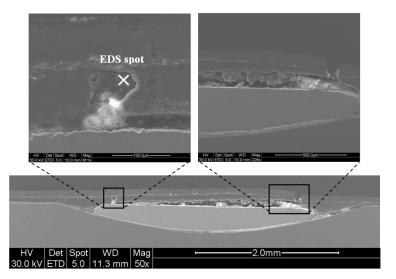
SEM-EDS results revealed excellent paint surface finish away from fastener head regions; but exhibited substantial paint defects, in the form of cracking and dislocation of layers (delamination); all of which were observed around fastener areas, see Figure 2. Numerous short, blunt cracks approximately normal to the paint surface had developed both at the external surface and interfacial layer. The cracks appeared to be consistent with movement associated with the fastener tilting or the stress concentration associated with joints as substantial displacement is expected at these locations. The examination supported a correlation between paint failure/cracking and mechanical displacement.

Figure 2: Scanning electron micrograph, showing paint defects and delamination underneath the paint film at fastener areas

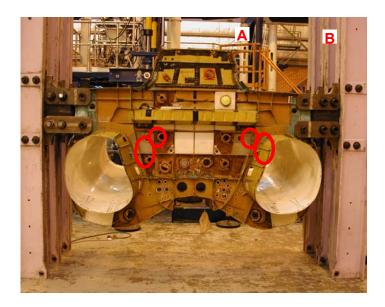
Figure 1: Locations (circled) on the Y453 bulkhead where a safe life extension was possible using DSTO's novel lead crack concept methodology. View looking aft.

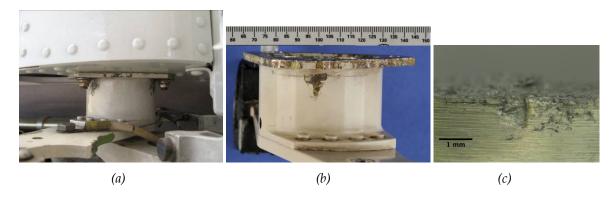
Figure 3: (a) Severe mechanical damage adjacent to the fastener nut, (b) Photograph showing the crack below the attachment point of the torque tube flange and (c) close up view showing multiple crack planes extending from the corrosion pitting

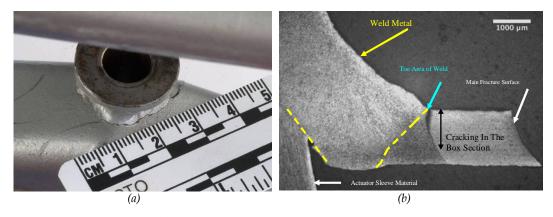
Figure 7: a) crack at the toe of the actuator support sleeve weld and continuing into the box section and b) Photomicrograph of the weld and plate material showing the secondary crack that had also initiated at the toe of the weld and progressed partially through the box section material
